Re: Ocean Chateau Condominiums
4049 Ocean Drive
Vero Beach, FL 32963
Engineer's Project No. 23-198

Milestone Structural Inspection

Ocean Chateau Condominiums

Phase I

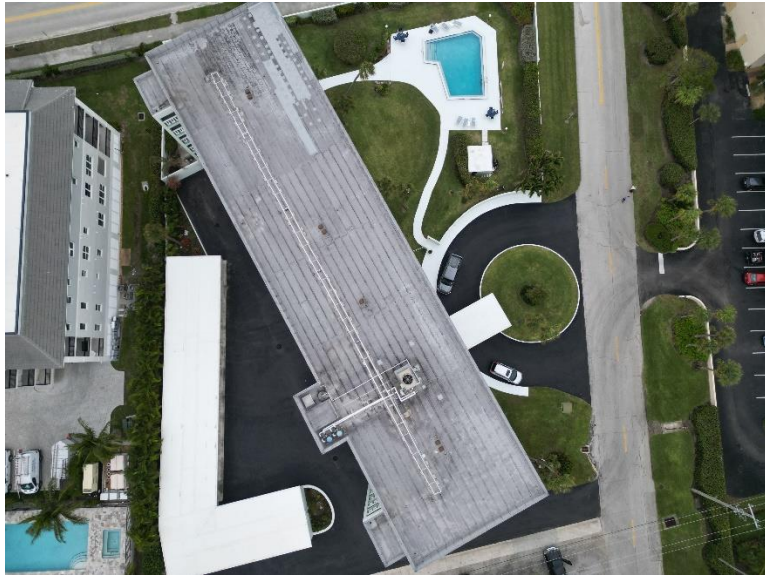
Figure 1 – Aerial view of structure

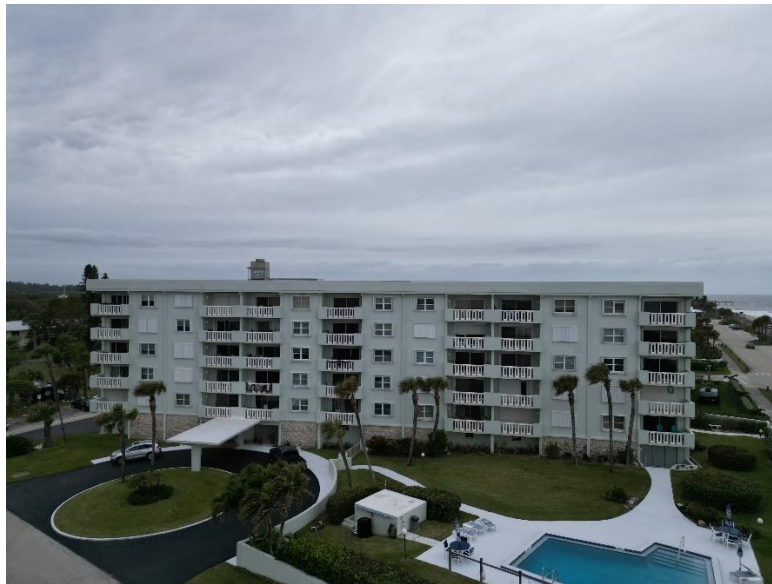
Pic 2 – South elevation

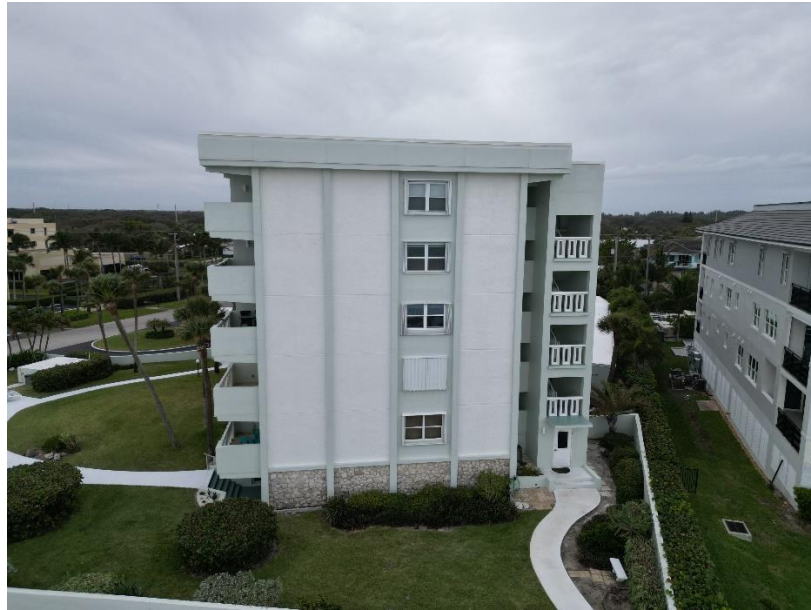
Pic 3 – East elevation

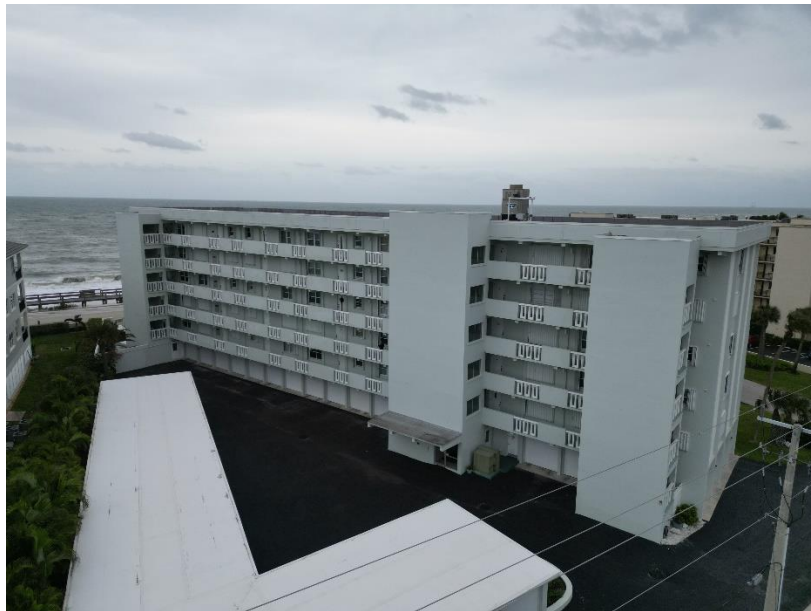
Pic 4 – North elevation

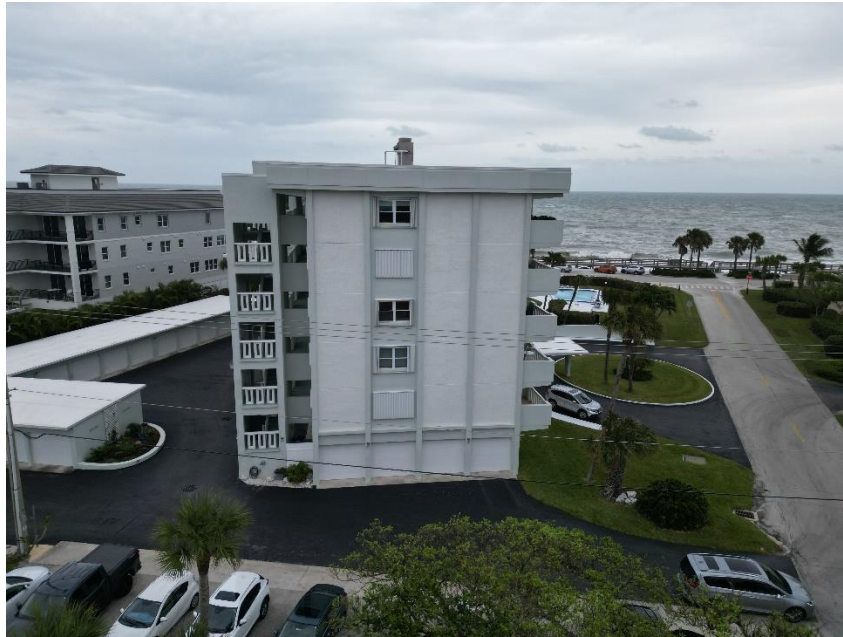
Pic 5 – West elevation

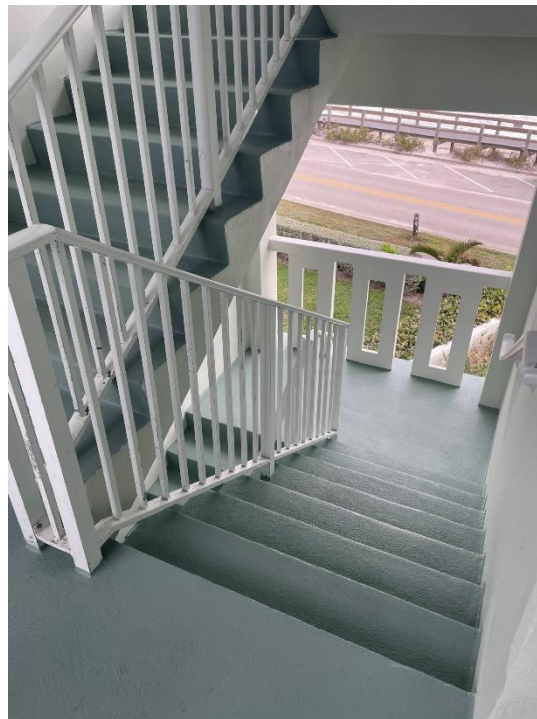
Pic 6 – East stairwell

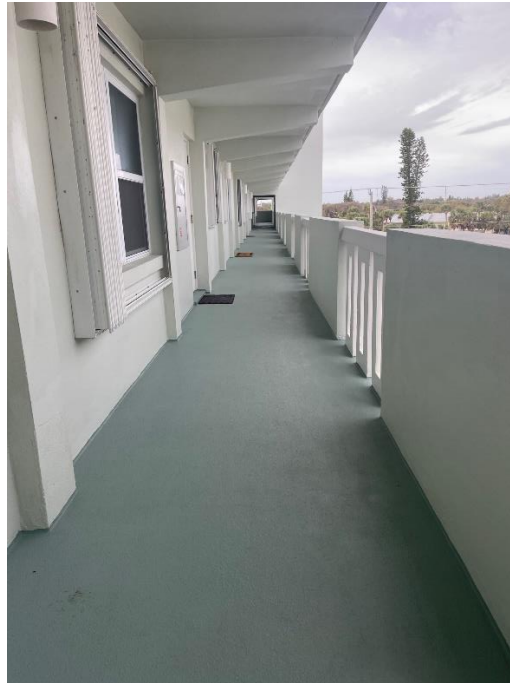
Pic 7 – Common walkway

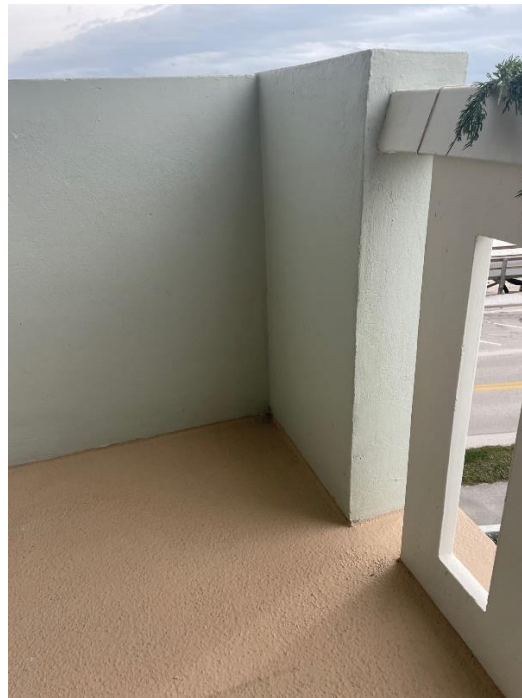
Pic 8 – Typical limited access balcony guardrails

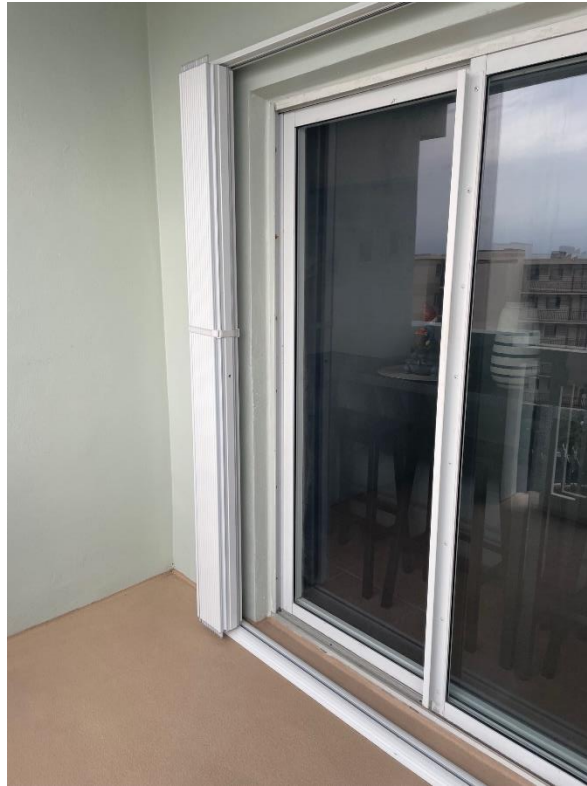
Pic 9 – Typical limited access balcony sliding glass doors w/ shutters

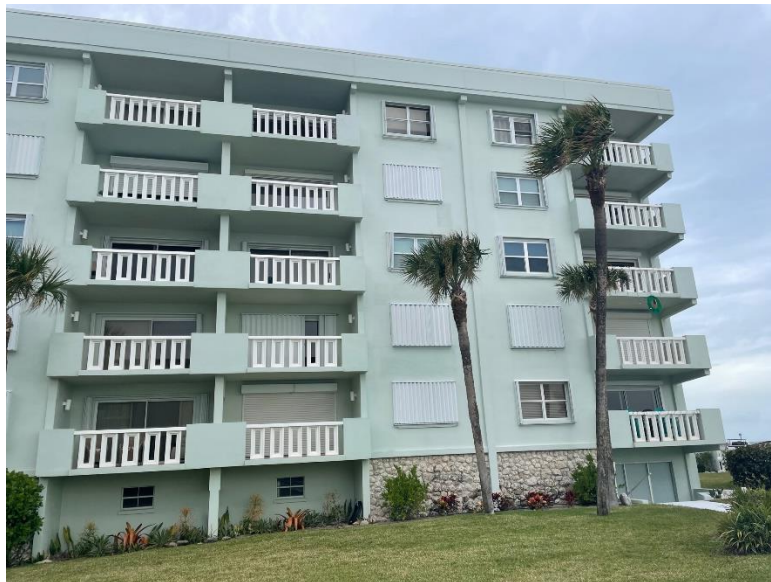
Pic 10 – Limited access balconies at the south elevation
